Front Elevation of the Inspected Property

The Attached Pre-Purchase Inspection & Fee & Invoice Agreement (IA)

The inspection will be carried out in compliance with AS4349.1-2007 except for Strata Units or properties where the inspection will be according with Appendix B of AS4349.1-2007.

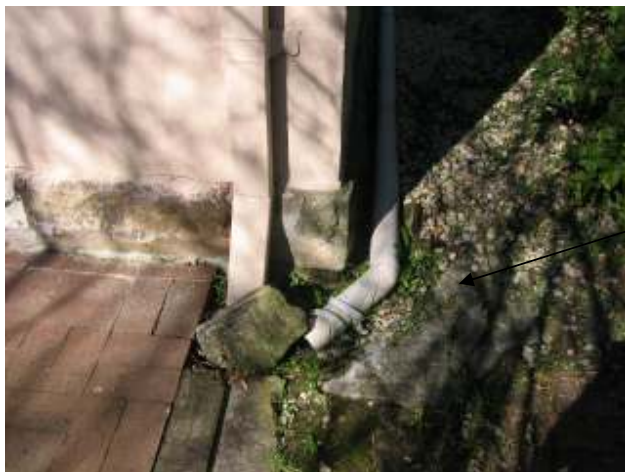
The right side stormwater drainage needs to be correctly connected into appropriate stormwater drainage.

8. The paving / concrete paths were in undulated and cracked condition around this dwelling.
9. The stormwater drainage laid on the right side should be connected appropriately.

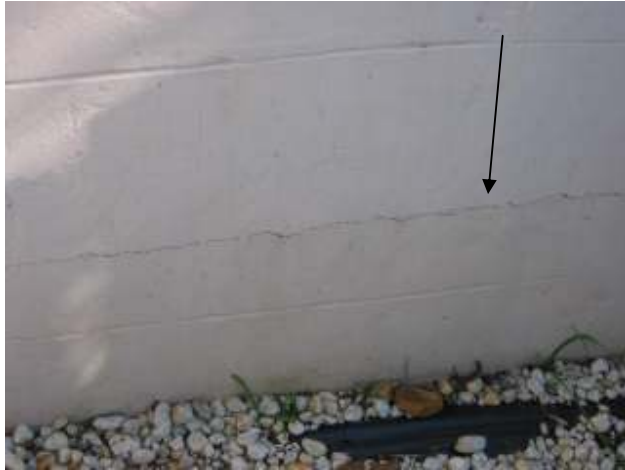
The left side of the garage wall is cracked, minor.

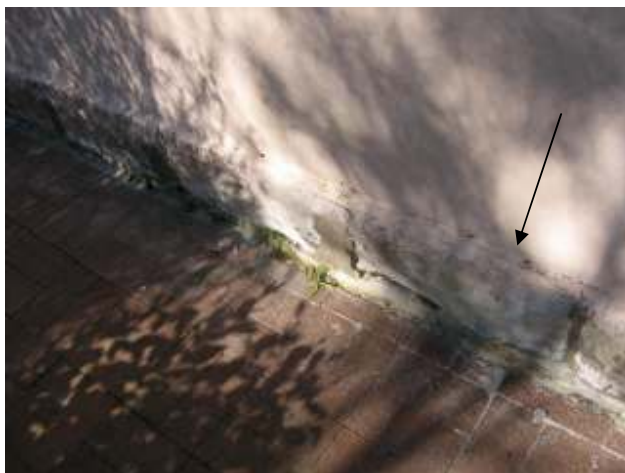
Some of the sandstone fender walls are damaged by rising damp in areas.

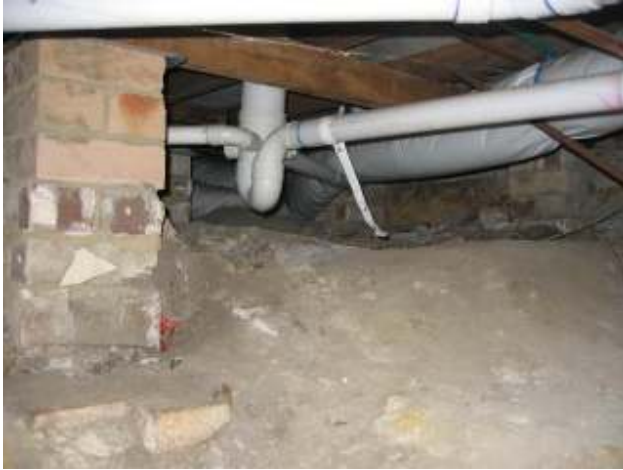
The rear left side sub floor access into an area that can not be accessed.

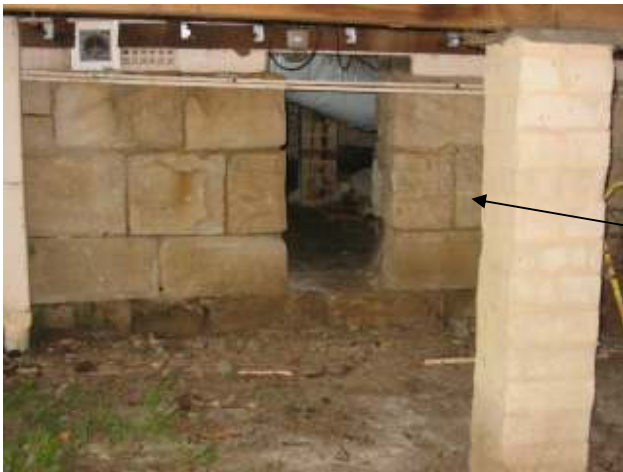
The other sub floor access area under the rear decking.

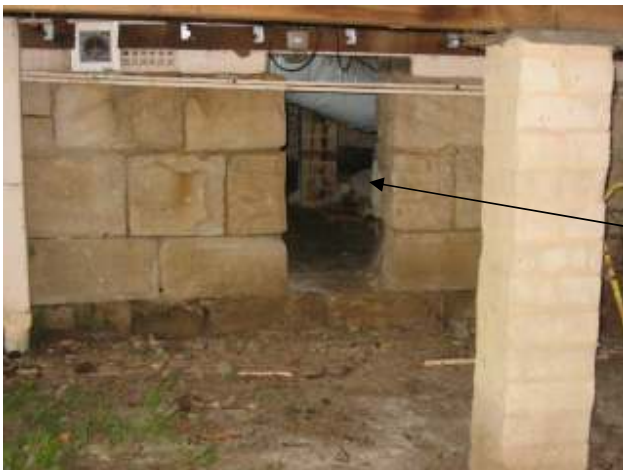
The other sub floor access area under the rear decking.

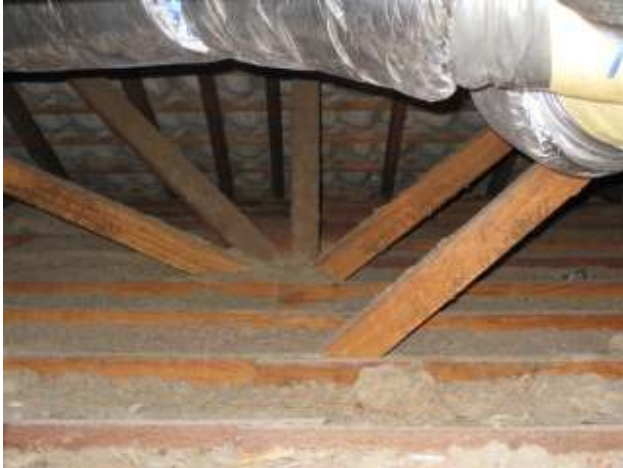
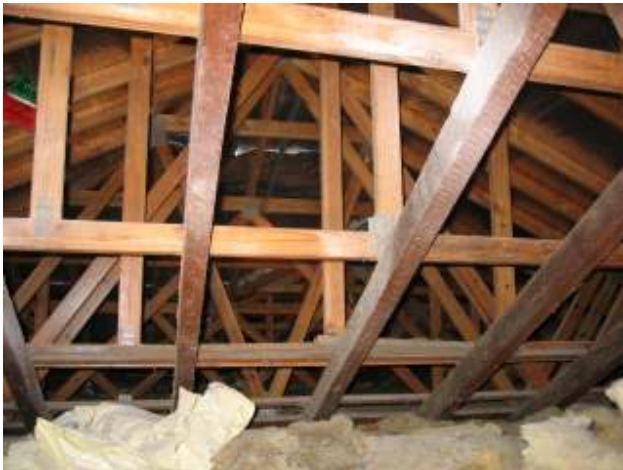
The photos below show a roof loft area that is of trussed construction which appears to comply with the code as to when this dwelling was first built. Access was hindered in this roof loft area by the valley series trusses and the A/C unit and its ducting.

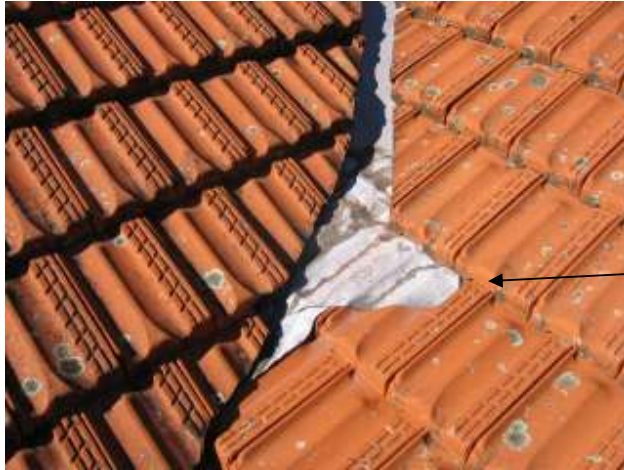
The lead flashings to the roof tile areas need to be painted to prevent further deterioration.

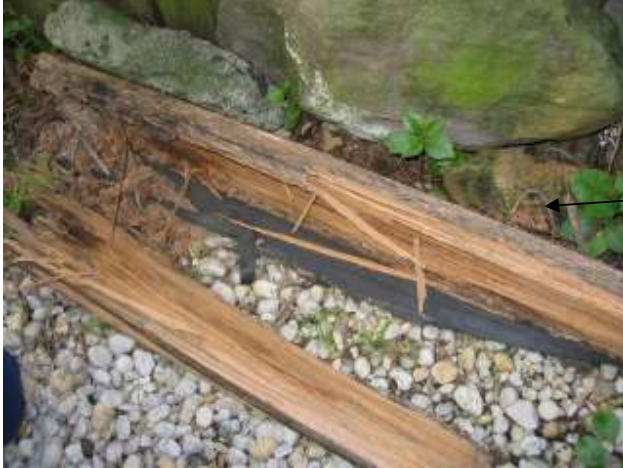
We make a general observation that there are Termite damaged timbers evident in the yard areas.

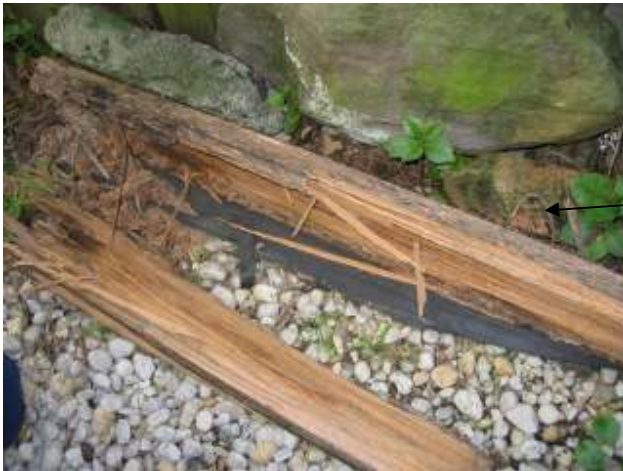
We make a general observation that there are Termite damaged timbers evident in the yard areas.

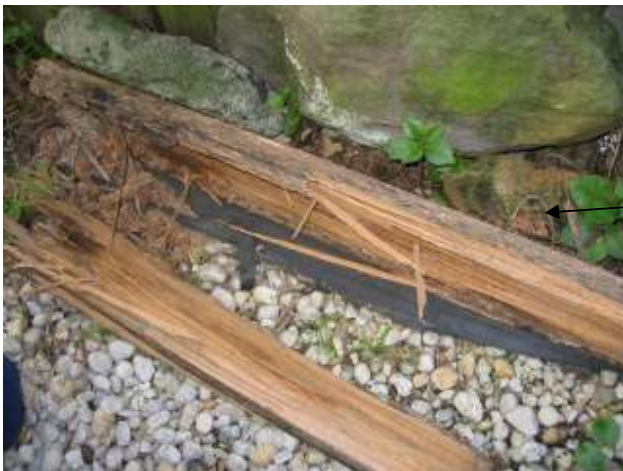
We make a general observation that there are Termite damaged timbers evident in the yard areas.

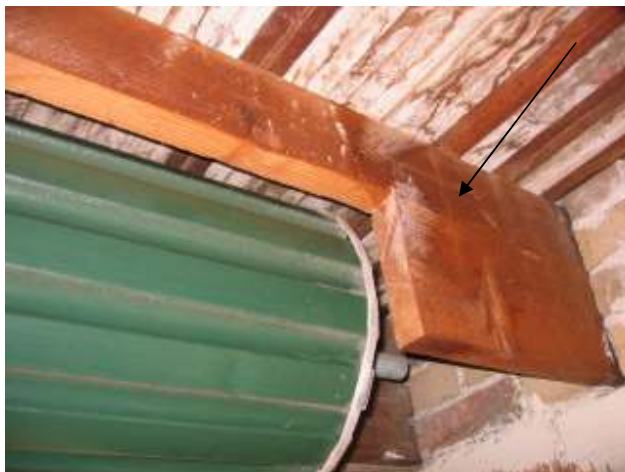
This garage ceiling joist has been poorly cut out to fit the roll-a-door, poor tradesman like works.

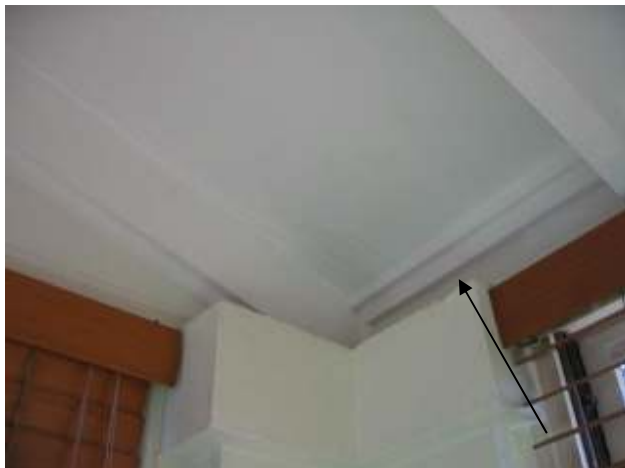
The front veranda room ceiling appears to be water stained from leaking above this area.

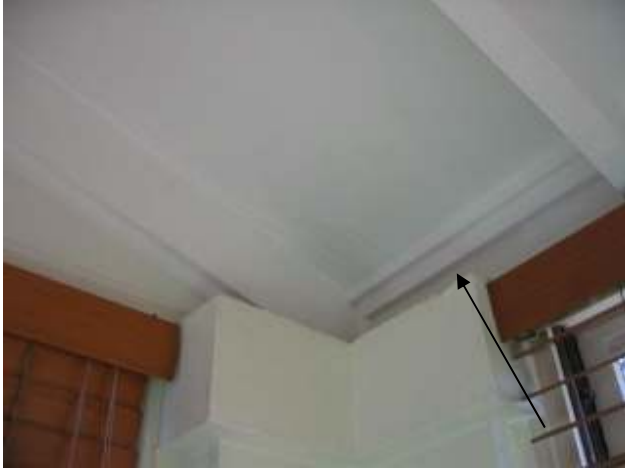
The front veranda room ceiling appears to be water stained from leaking above this area.

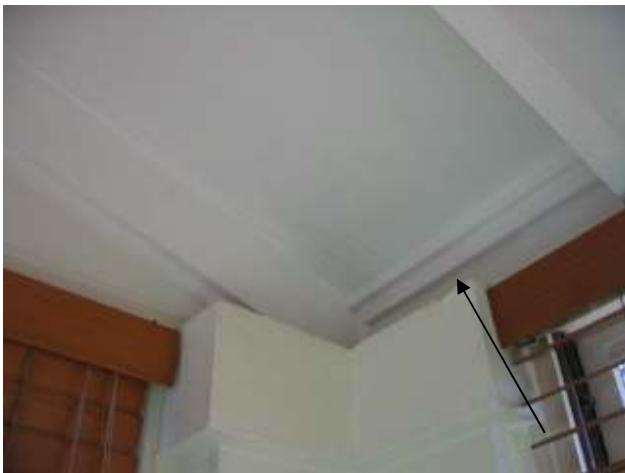
The front veranda room ceiling appears to be water stained from leaking above this area.

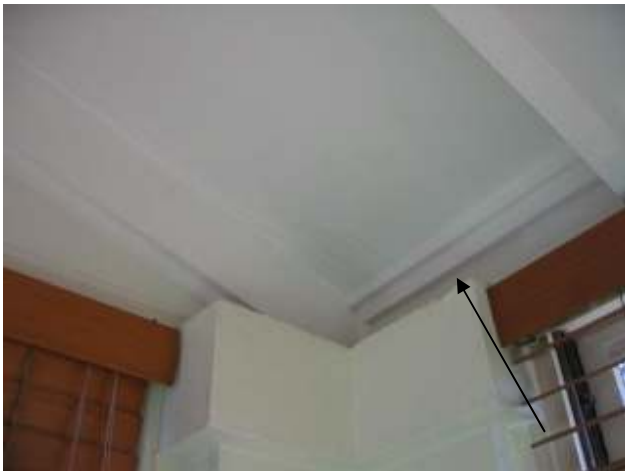
The front veranda room ceiling appears to be water stained from leaking above this area.
