Front Elevation of the Inspected Property

The Attached Pre-Purchase Inspection & Fee & Invoice Agreement (IA)

The inspection will be carried out in compliance with AS4349.1-2007 except for Strata Units or properties where the inspection will be according with Appendix B of AS4349.1-2007.

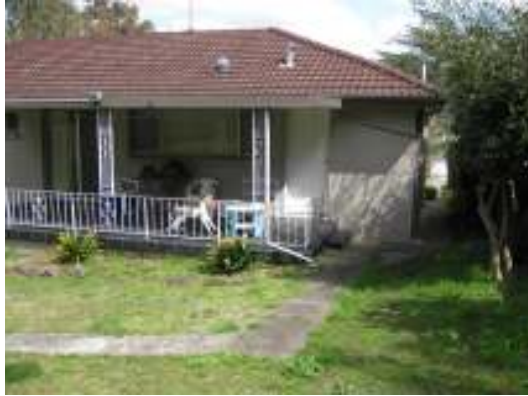
Out building/s: *Unit was in poor/fair/average condition, unit needs to be demolished, gutters in poor and rusted condition, asbestos lined in areas, timber frame is wood decay affected in areas.*

Granny Flat unit/As Inspected.
